**REPORT NO 20/91/DK**

**MAY 2021**

### **GEOTECHNICAL INVESTIGATION FOR HALFWAY HOUSE WATER UPGRADE PROJECT: MIDRAND AND WATERFALL CITY, GAUTENG – FINAL**

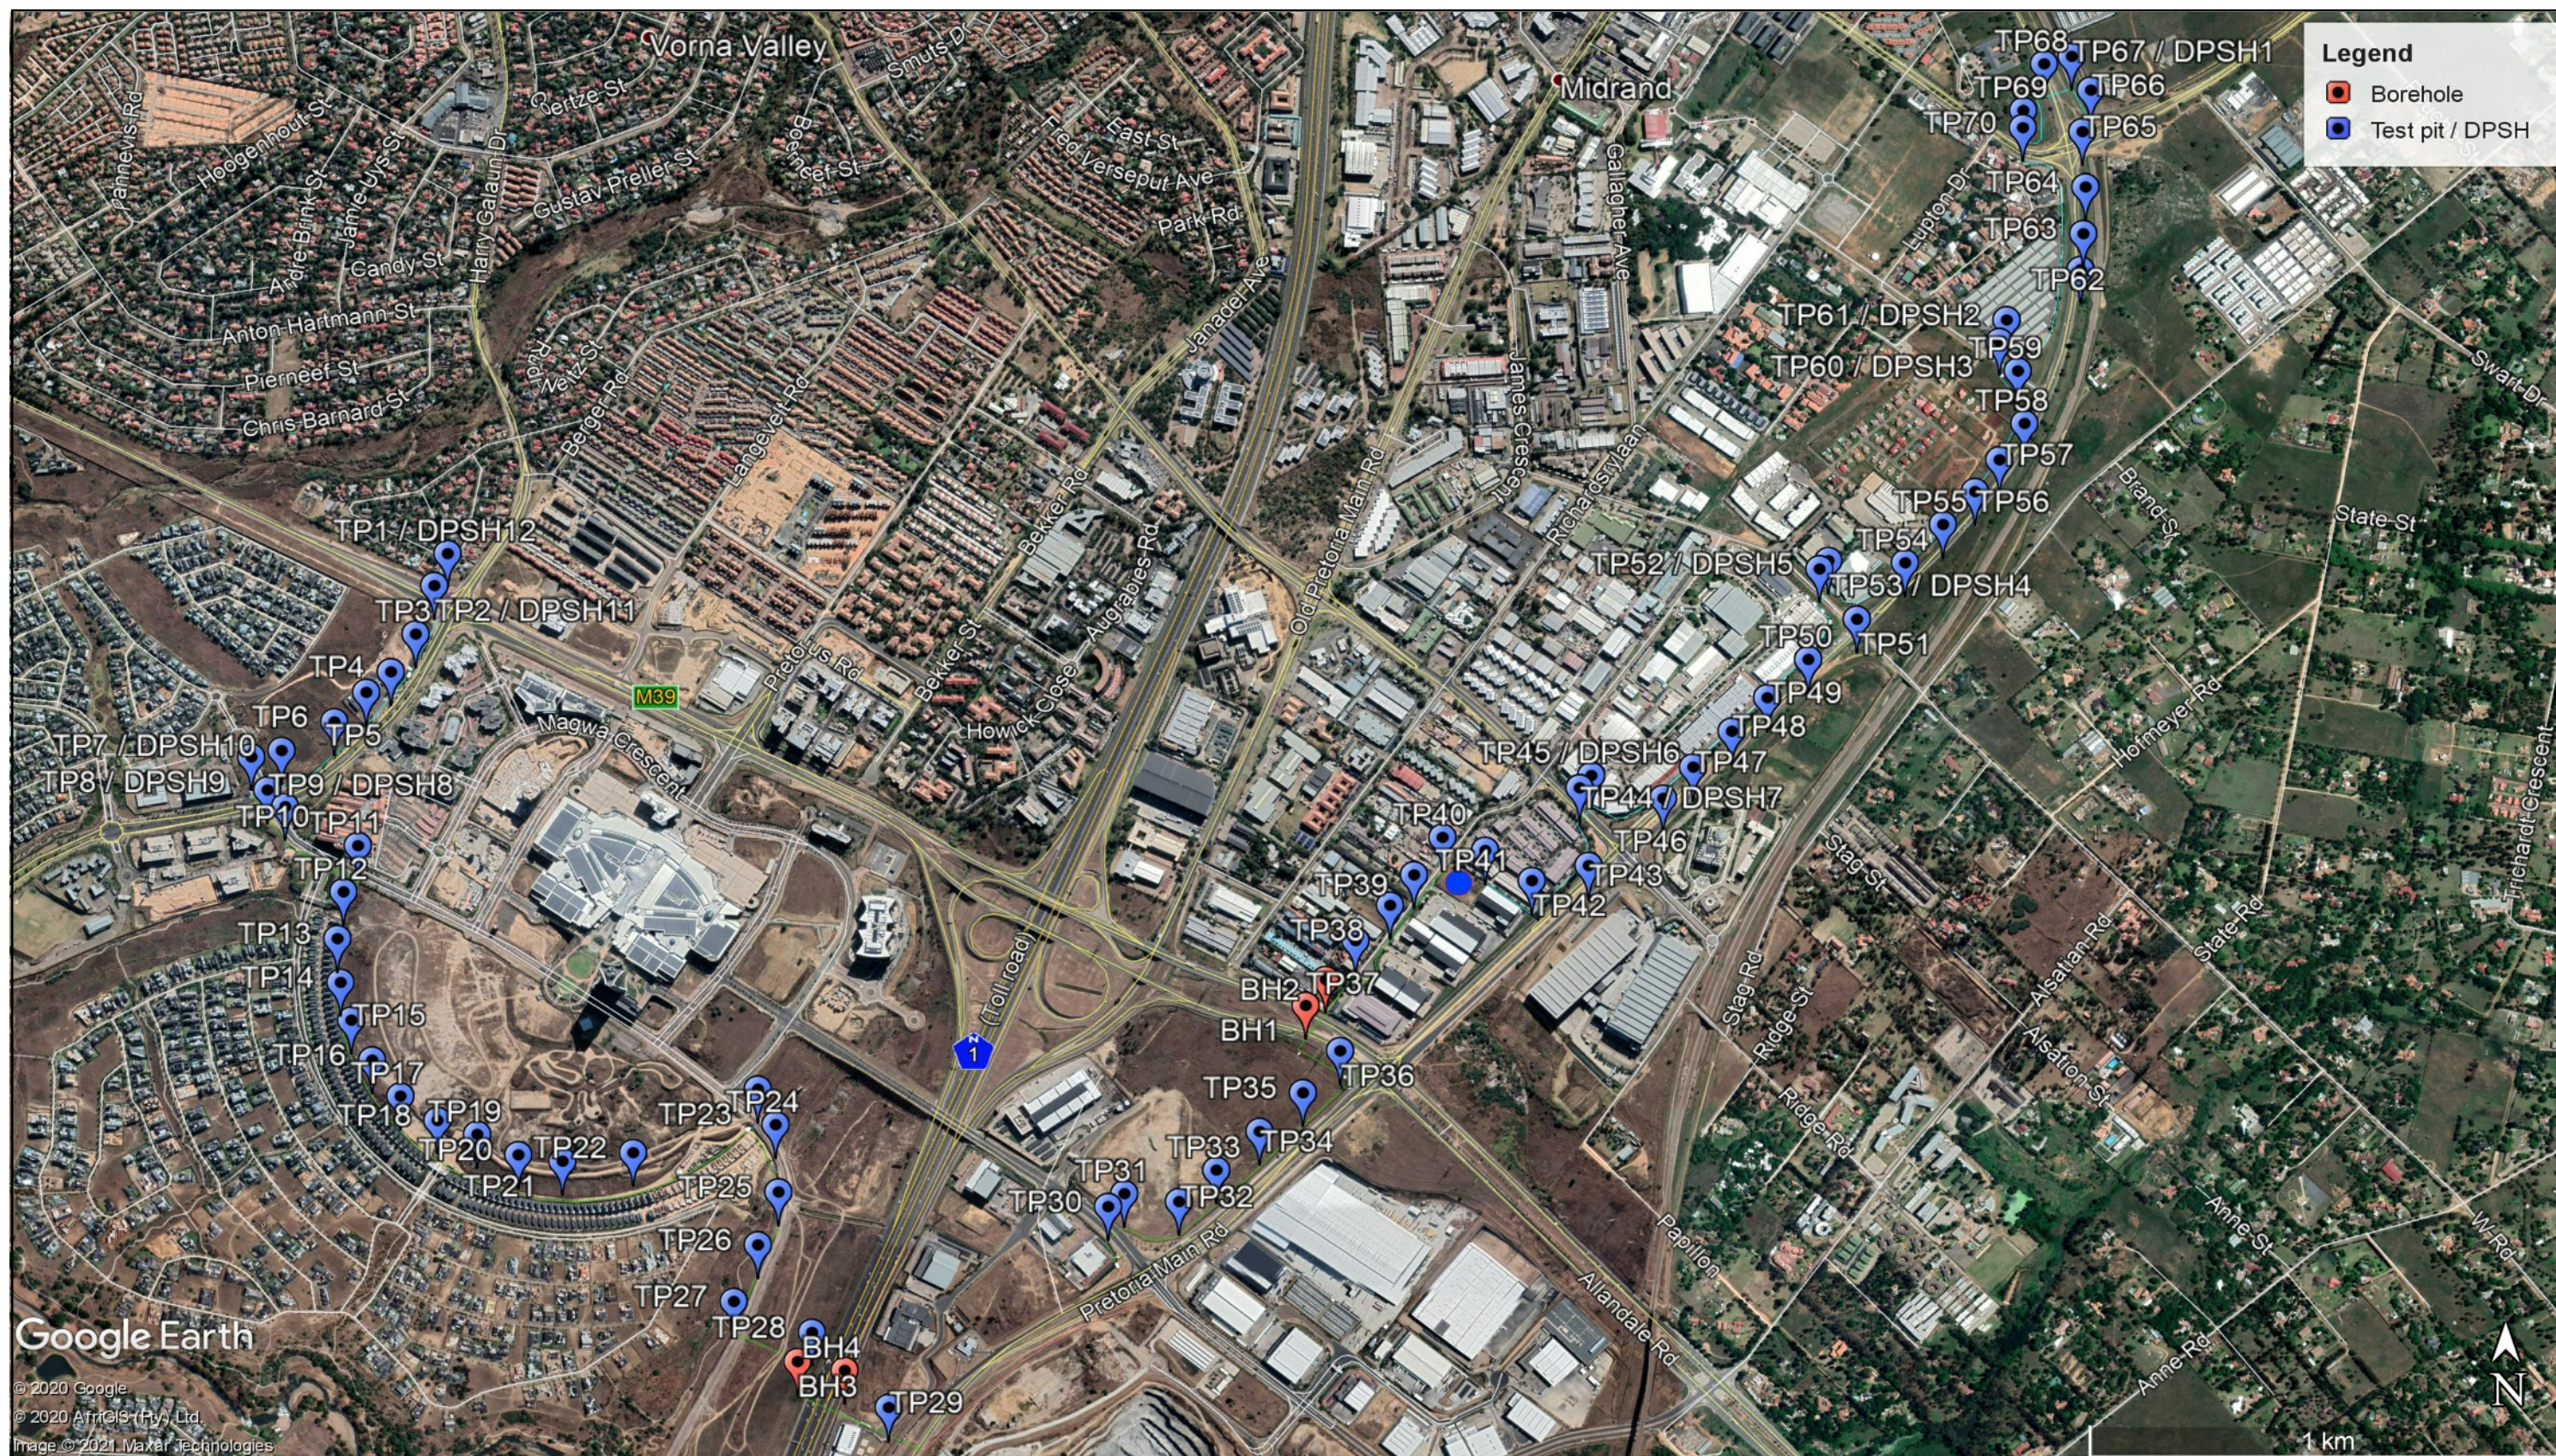
**SITE PLAN INDICATING APPROXIMATE POSITIONS  
OF TEST PITS, BOREHOLES AND DPSH TESTS**
